INTERNAL TESTS

Arc washbasin

Sample: Arc washbasin
 Date: 30/06/2025
 Tester #1: Jonathon Drummond
 Tester #2: Lizzie Waters
 Reason for test: Strength & Stability Tests

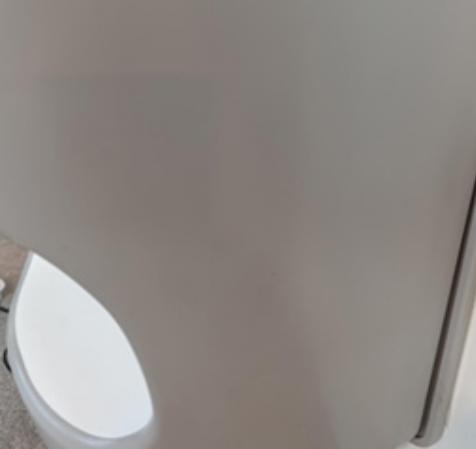
<p>A rubber paving maul (weighing approx. 8kg) hit against the side for 5 minutes.</p> <p>Observations - No damage.</p> <p>- Pass</p>
Mini Impact Test

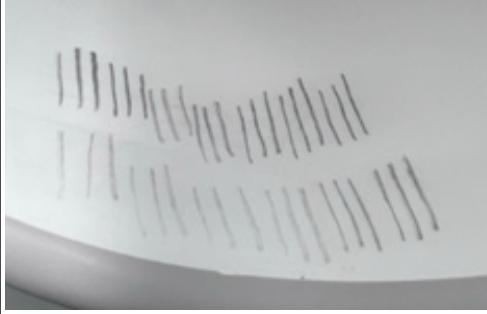
<p>Starting from an 8B pencil we push at an approx. 45-degree angle into the surface and if there isn't any damage we move up to the next pencil the hardest being 4H.</p> <p>Results: No scratching on the surface; all pencils passed (tested up to 4H).</p> <p>-Pass</p>
